Accomplishment Report of Repair and Maintenance of Physical Facilities for the Training Calendar Year 2020

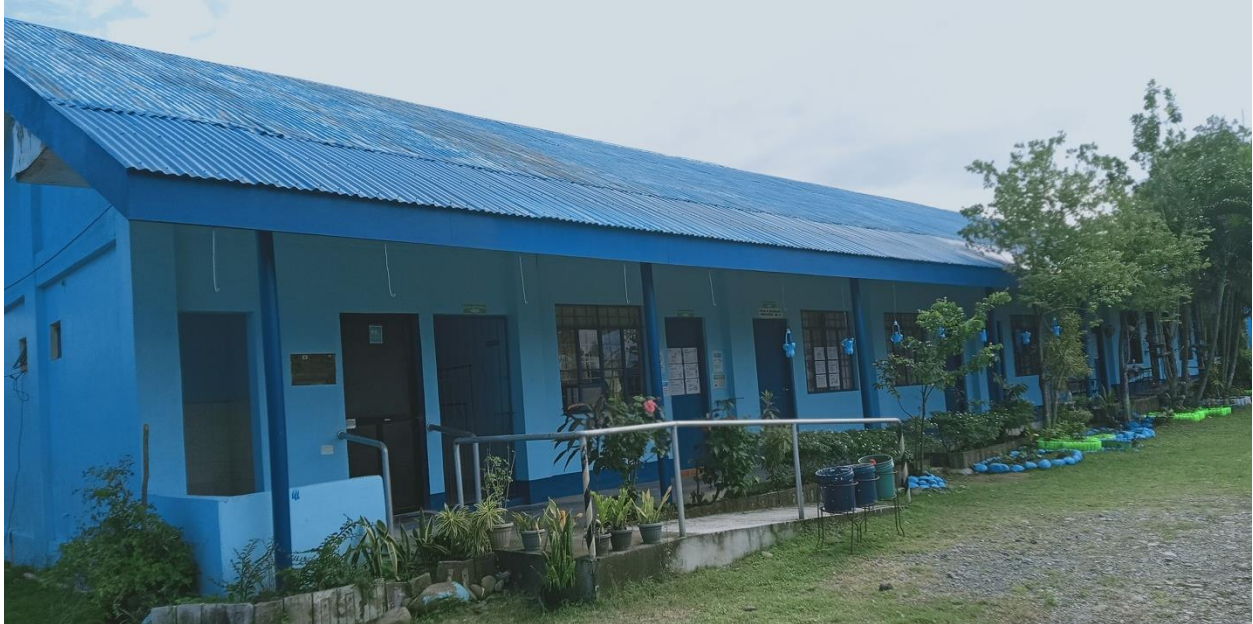
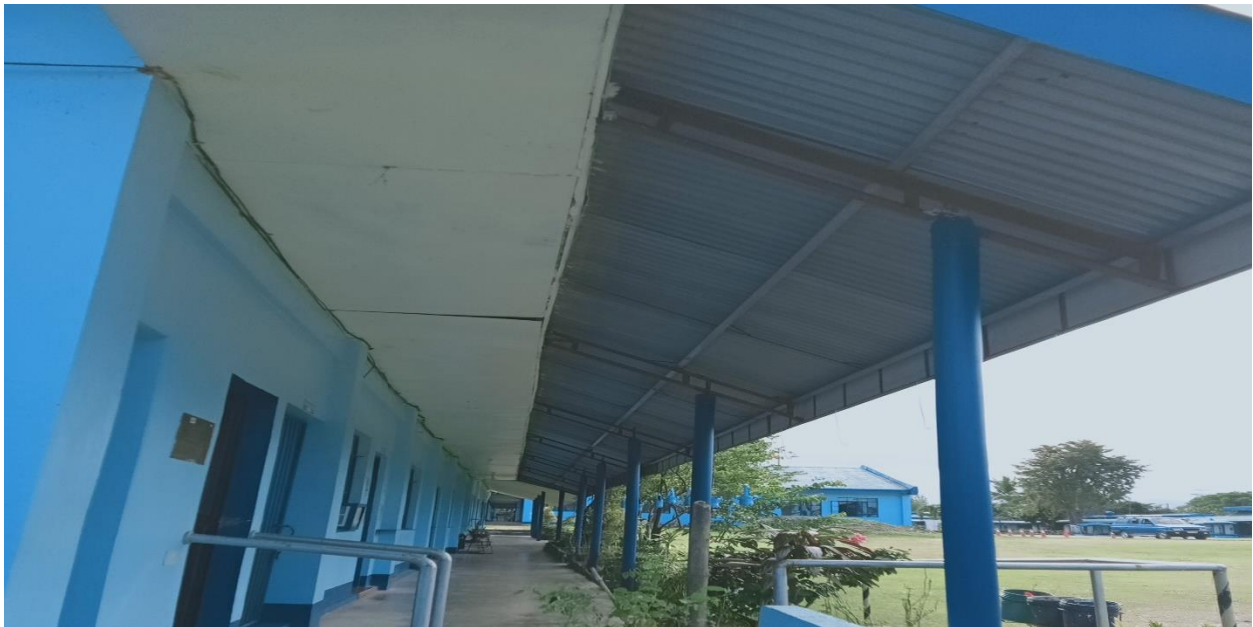
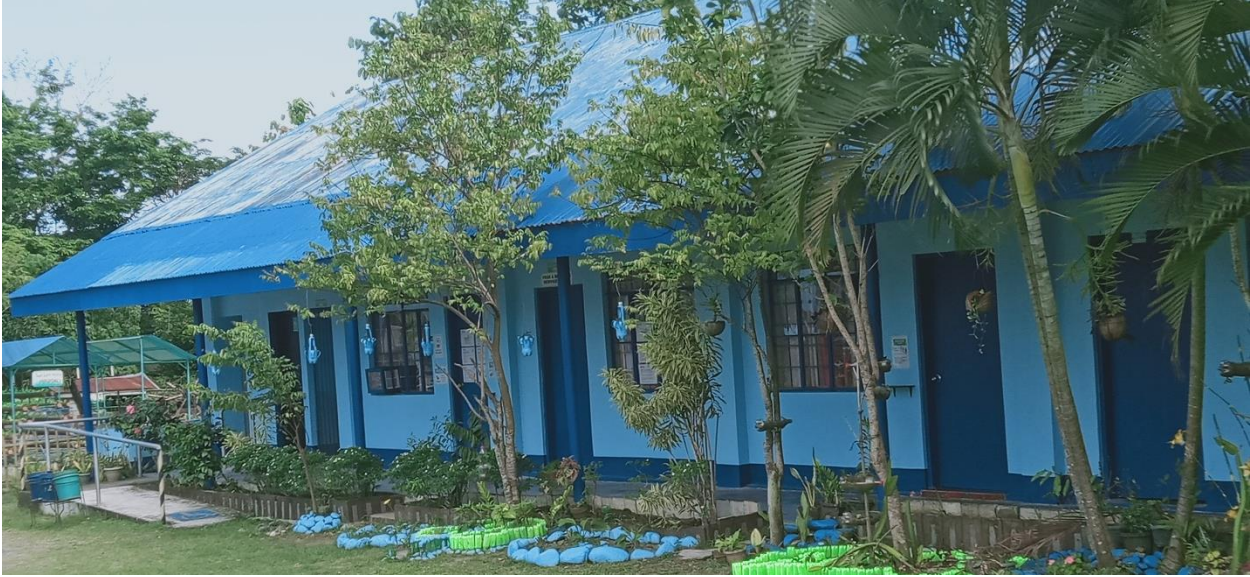
1. Repair and Maintenance of Housekeeping Pathway Roof Extension damaged by typhoon

Housekeeping building with extended roof for pathway cover.

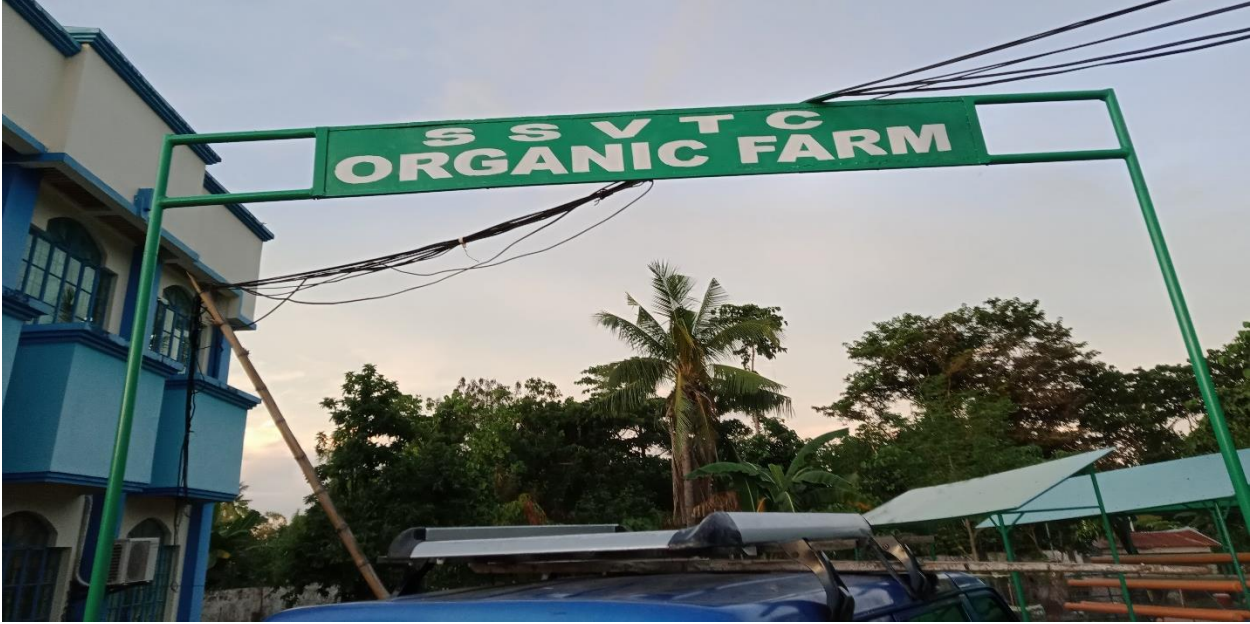
Main Entrance of Organic Farm

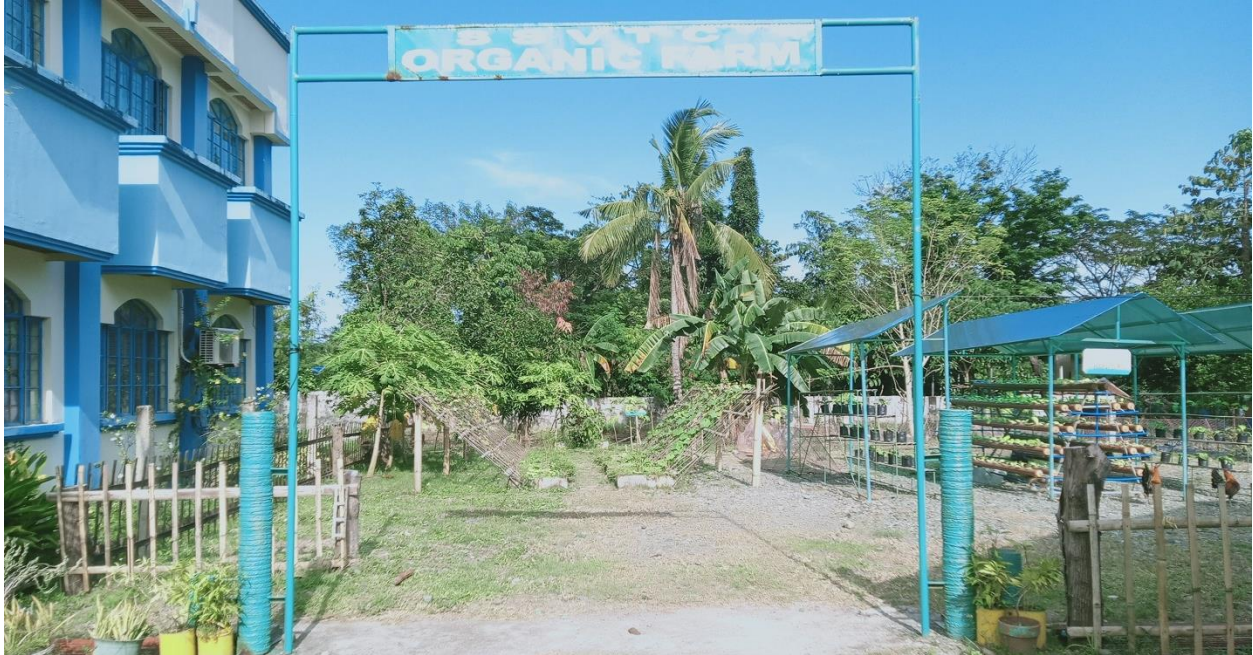
Plant Trellis and Hydroponics

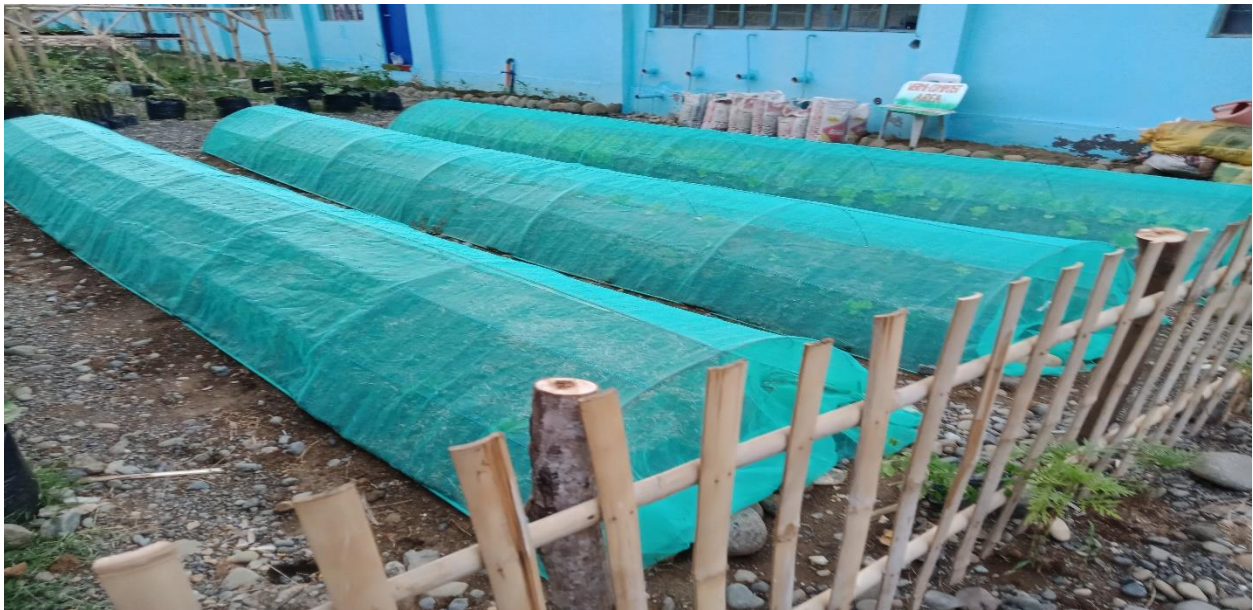
Plots for Plants made of Nylon and Steel Frame

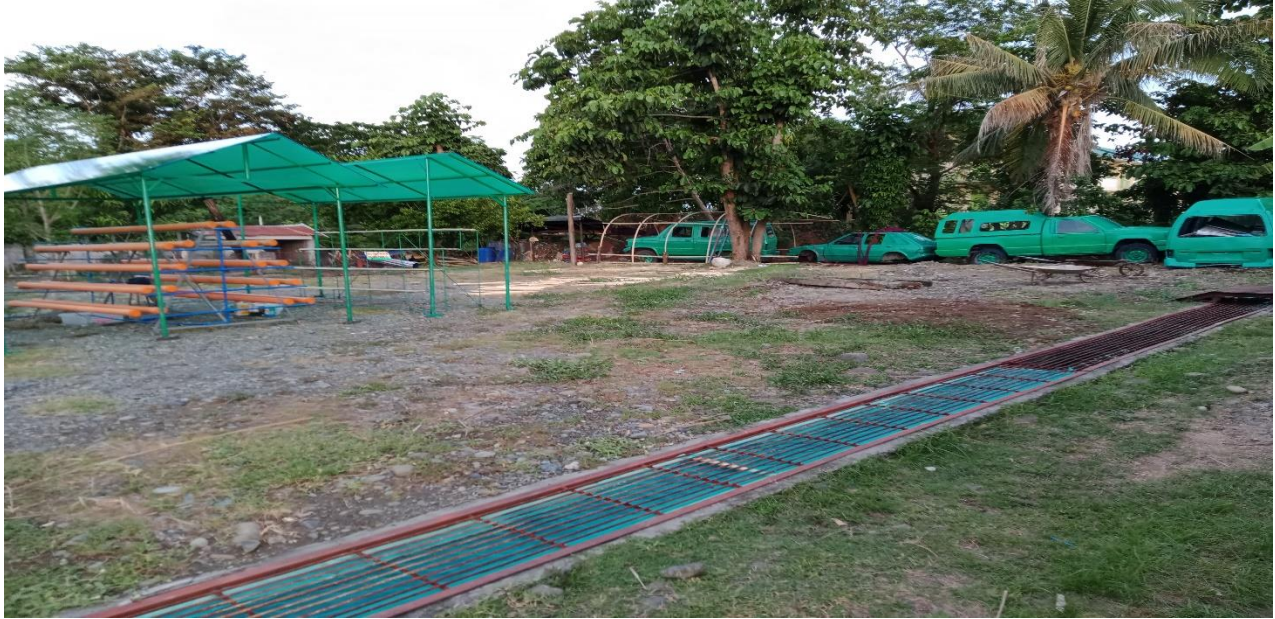
Canal with water supply for Tilapia Fish pond / Unserviceable cars were repainted with green and in secured with bamboo perimeter for cage of Organic Chicken Cage

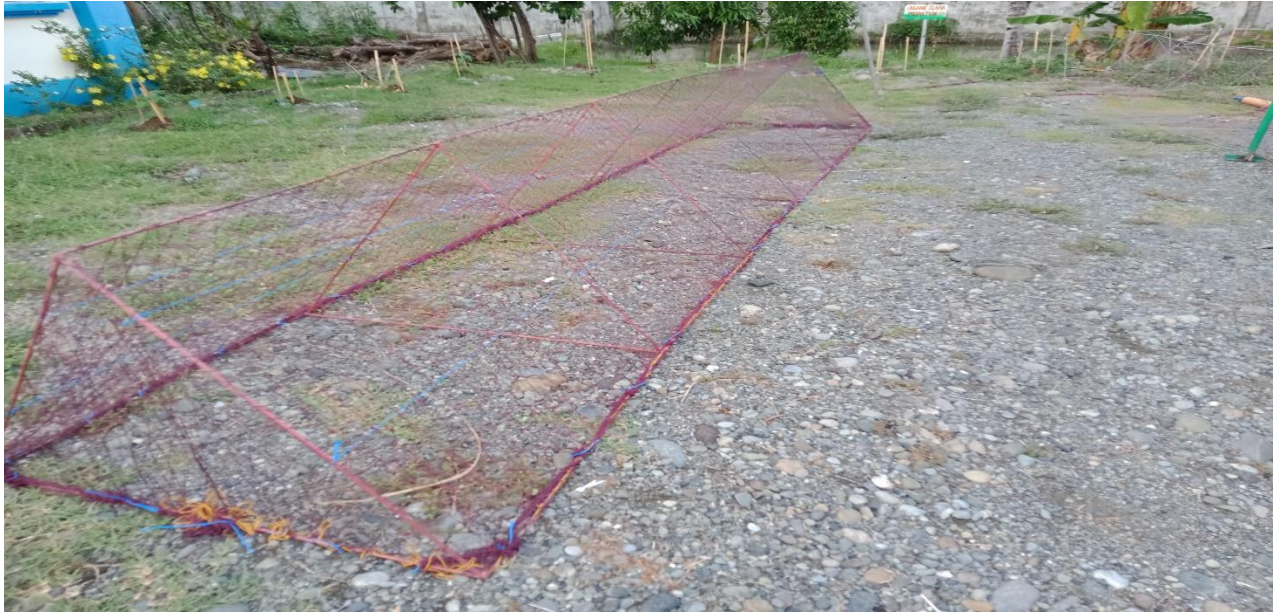
Cage and passage way for organic chicken.

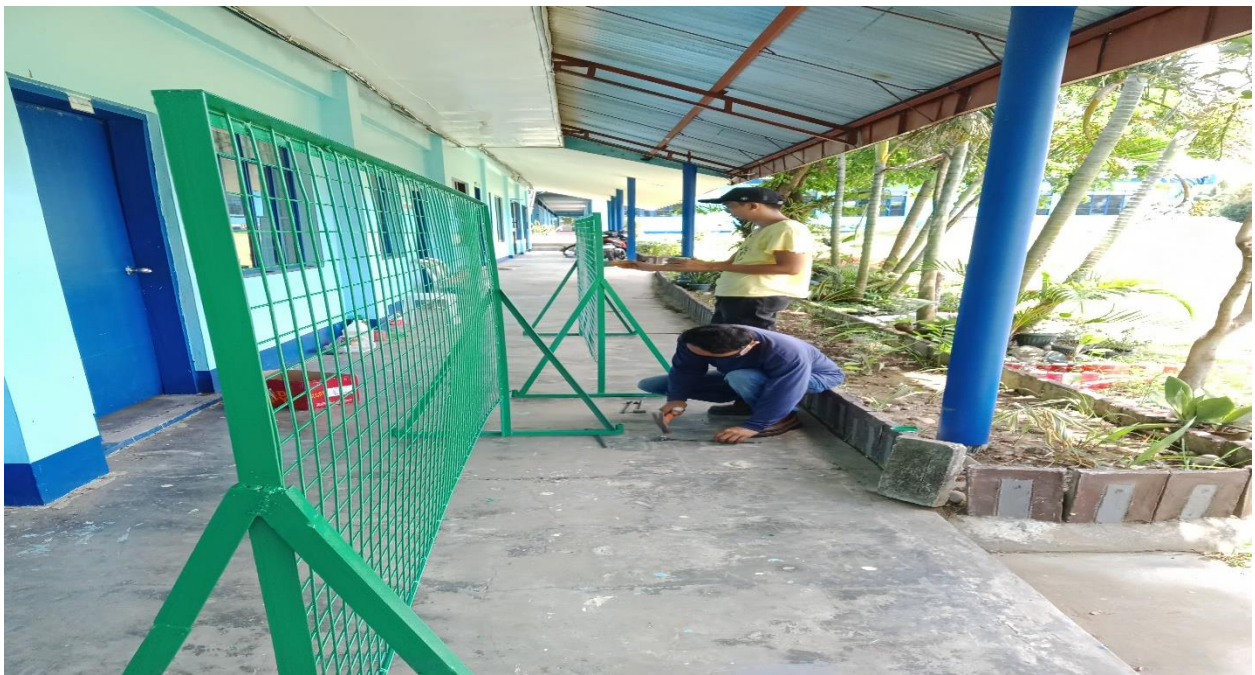
Frame for ornamental and vegetable plants

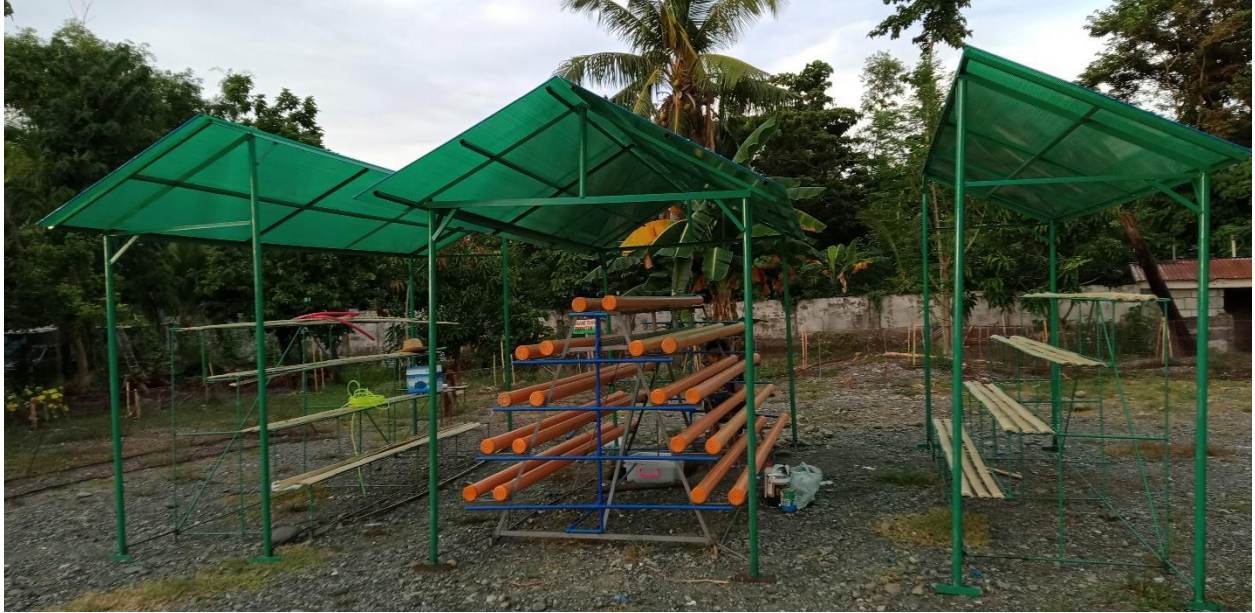
Station for Hydroponics planting facility

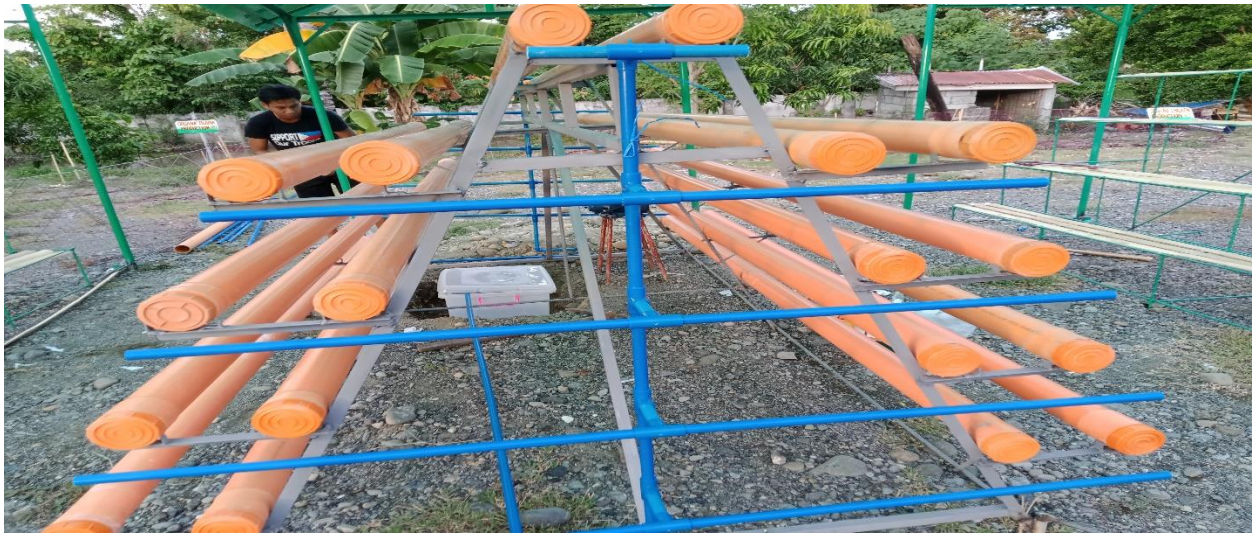
Hydroponics installed with steel frame, PVC pipes and water supply system

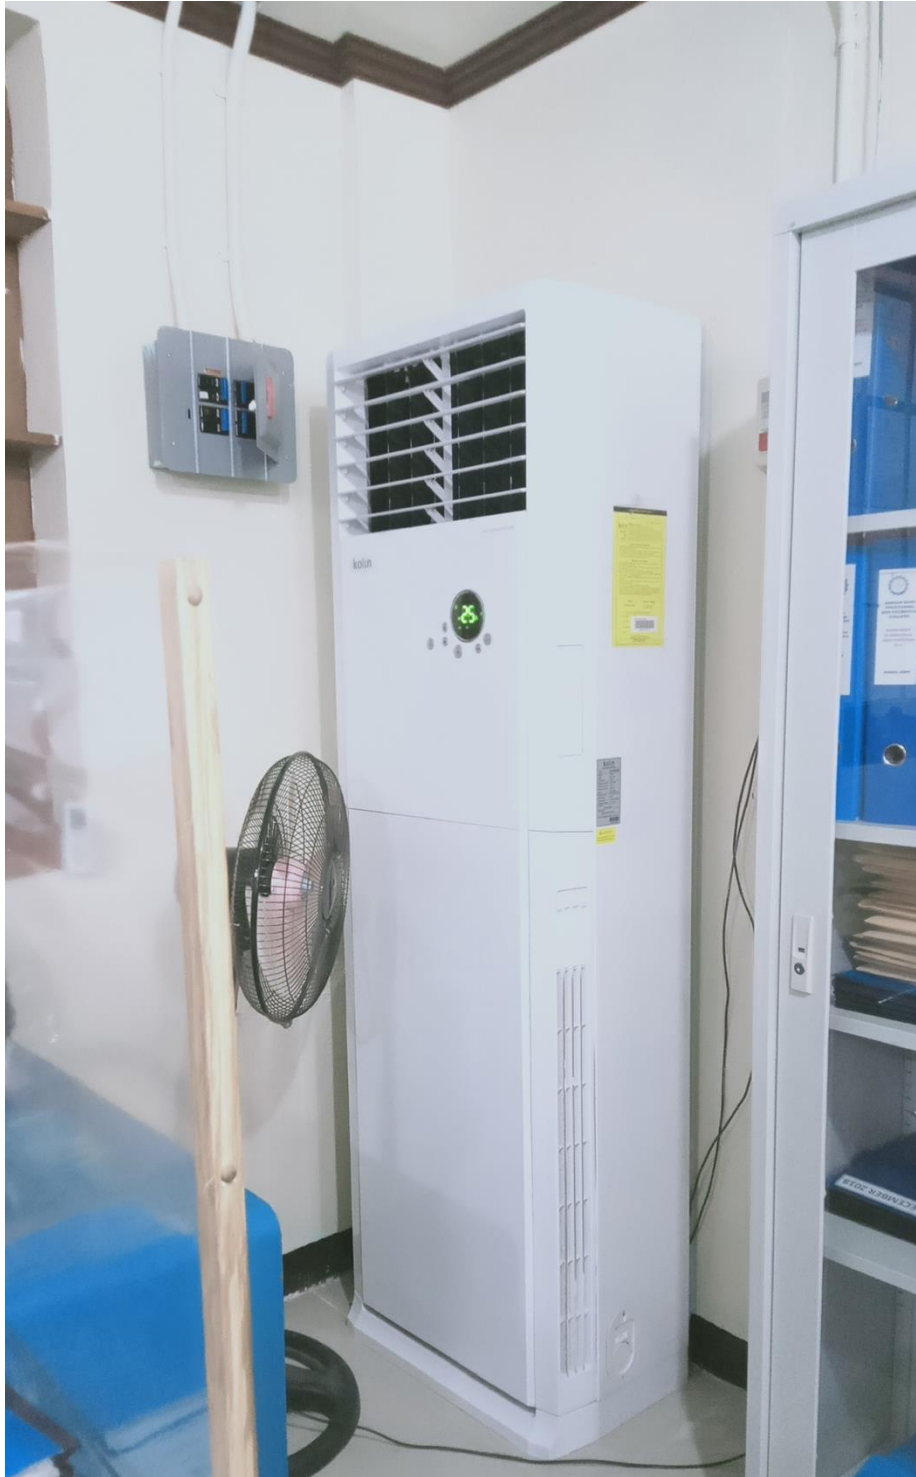
Installed Air Conditioning Unit at the Relocated Assessment Office

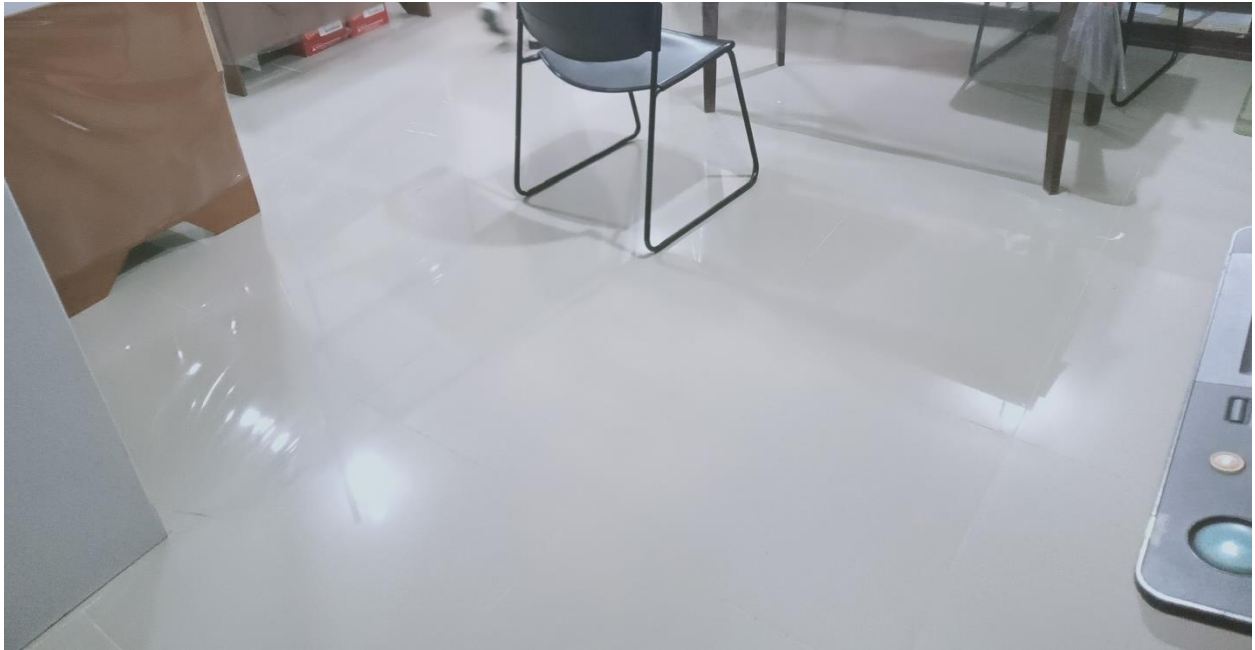
Tiles installed at the flooring of Assessment Office

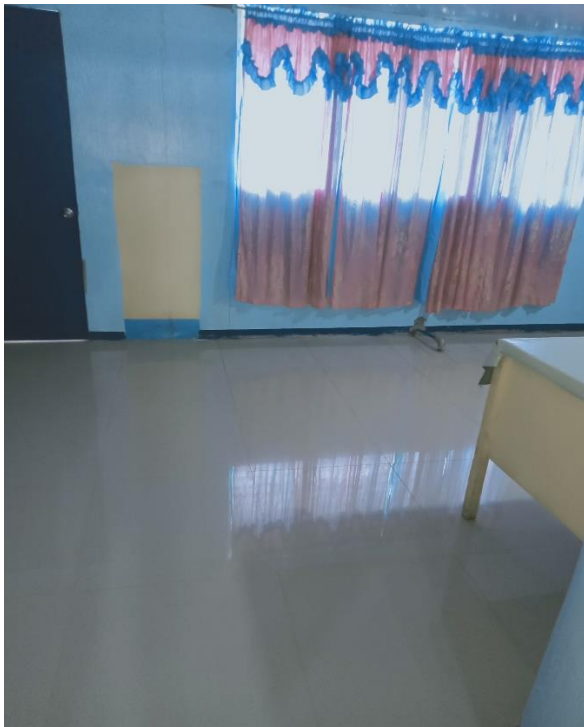
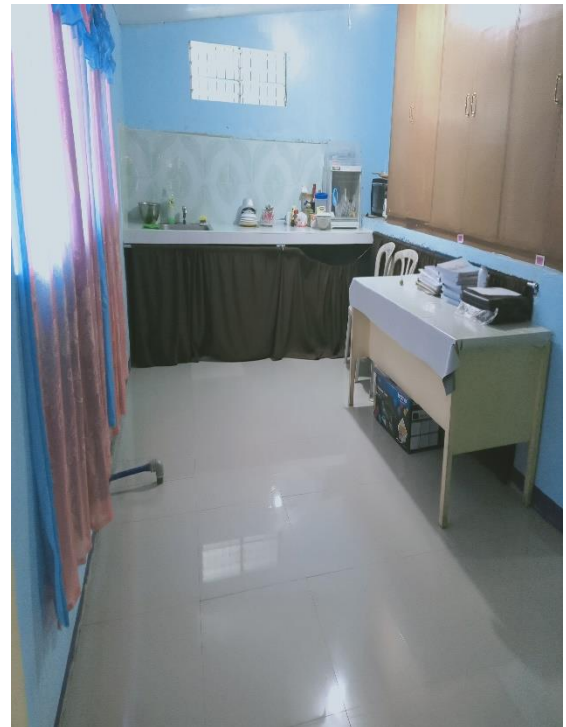
Tiles installed at the flooring of Pantry of Assessment Office

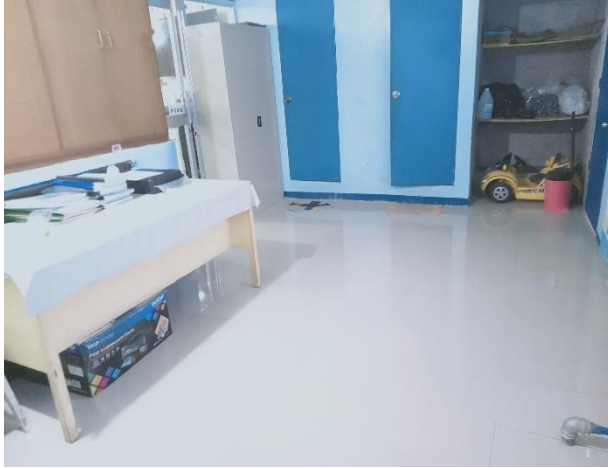
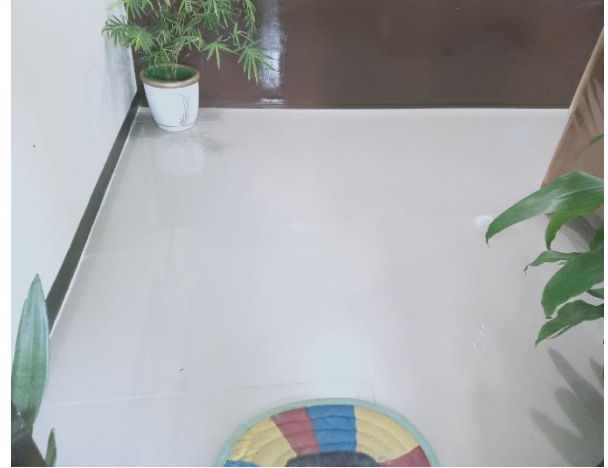
Tiles installed at the flooring of Lobby of Assessment Office

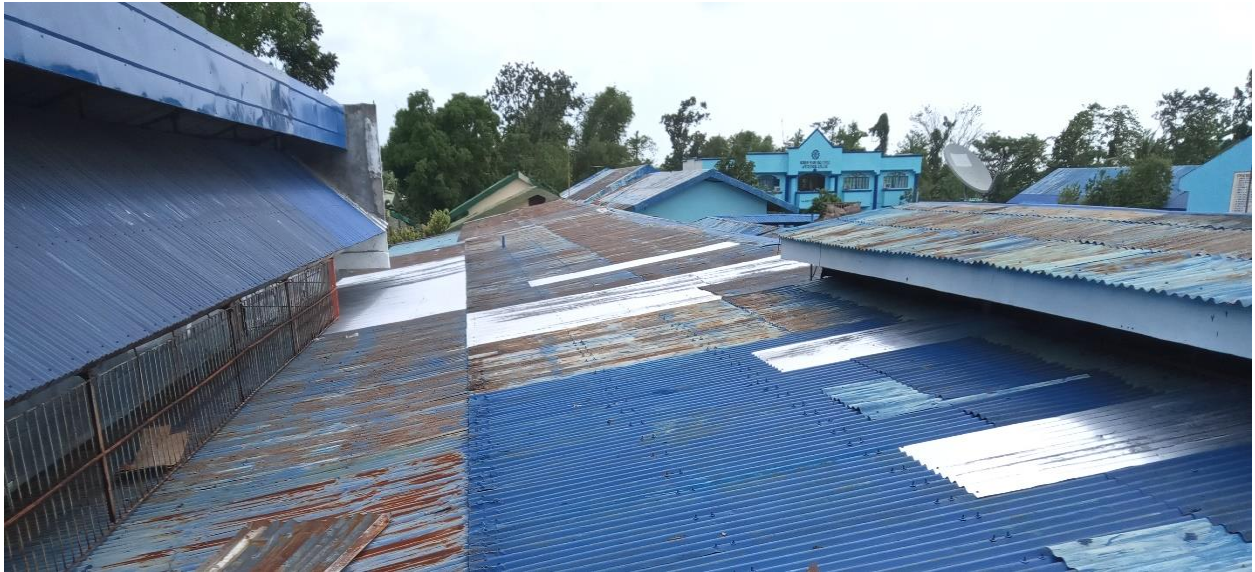
Repaired Building Roof of Welding and Conference Hall

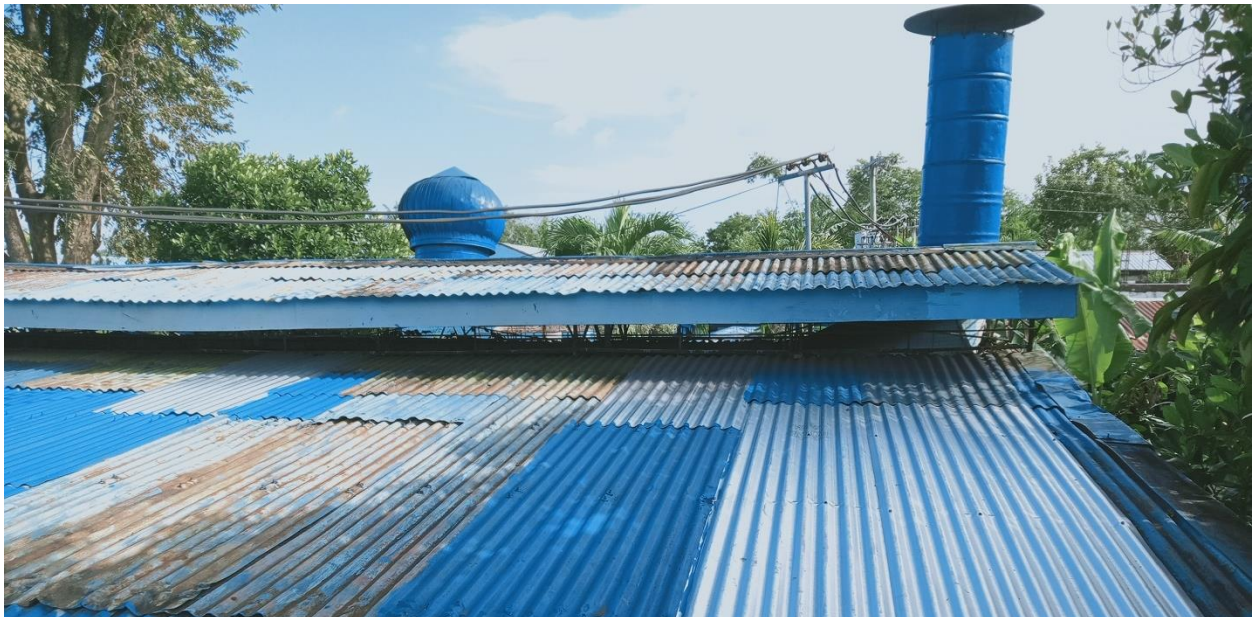
Repaired Building Roof of Welding Building

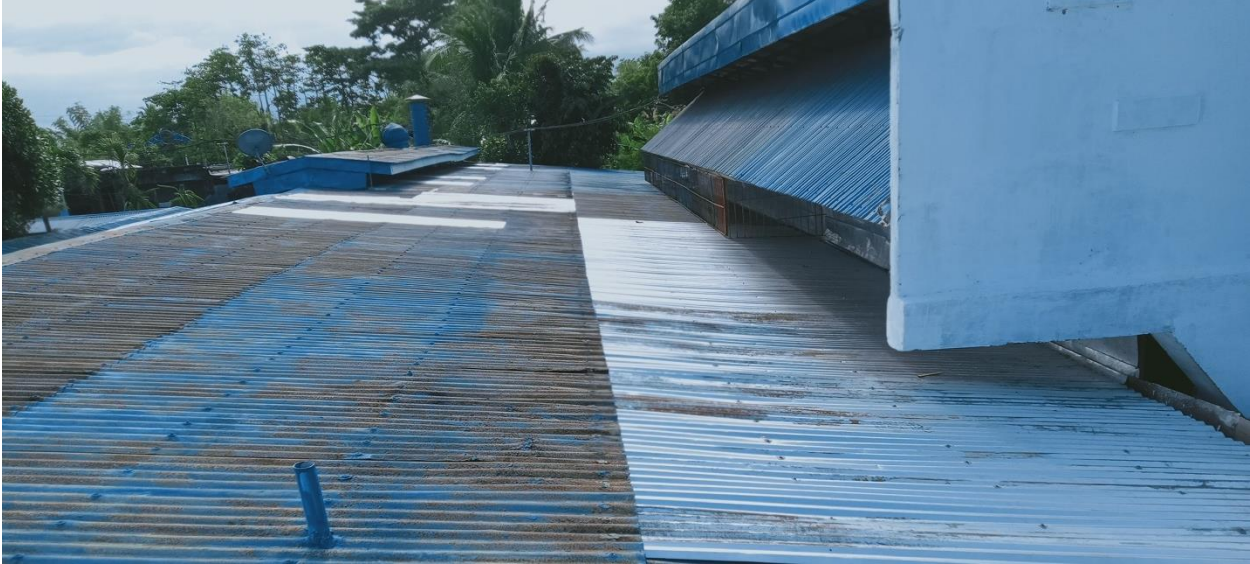
Repaired Building Roof of Welding and Conference Hall

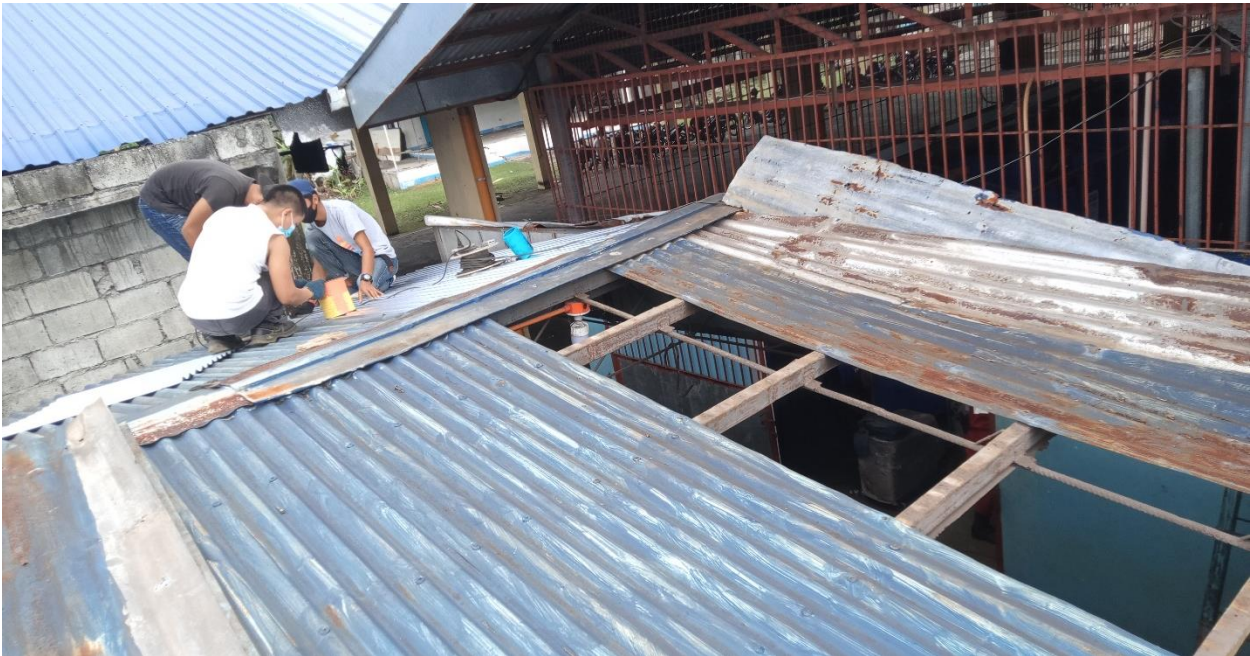
Repaired Building Roof of Welding laboratory waste and segregation area

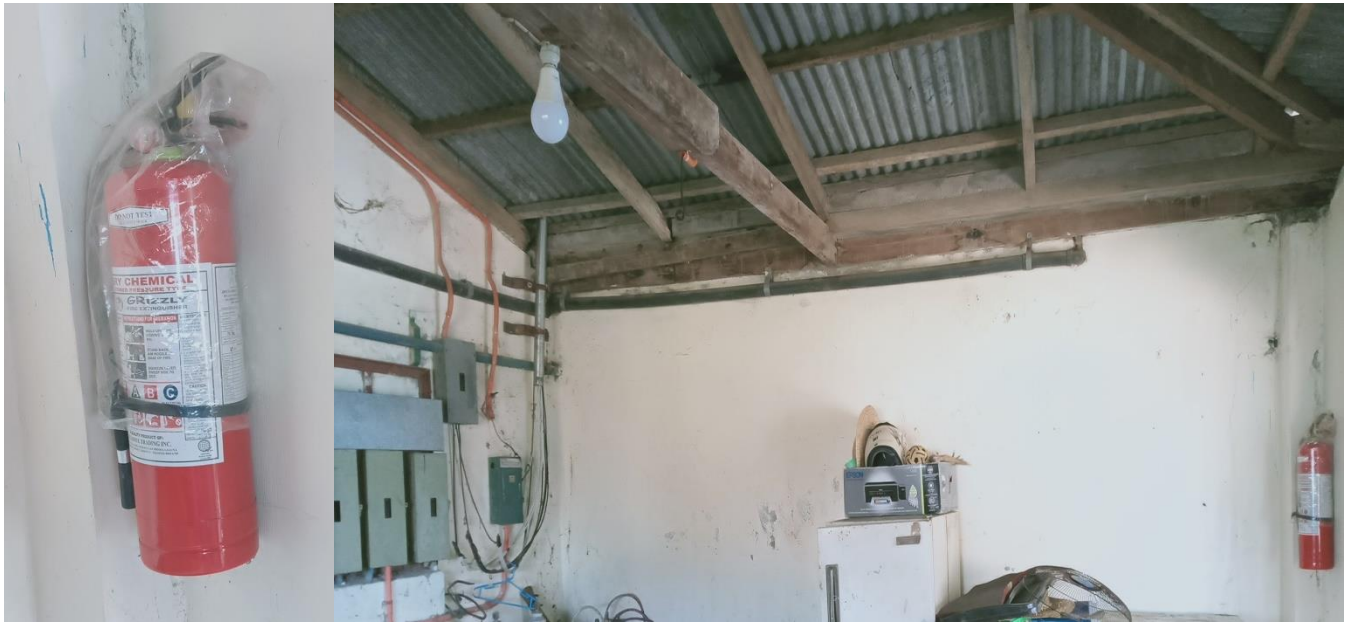
Installed Fire Extinguisher at Power House

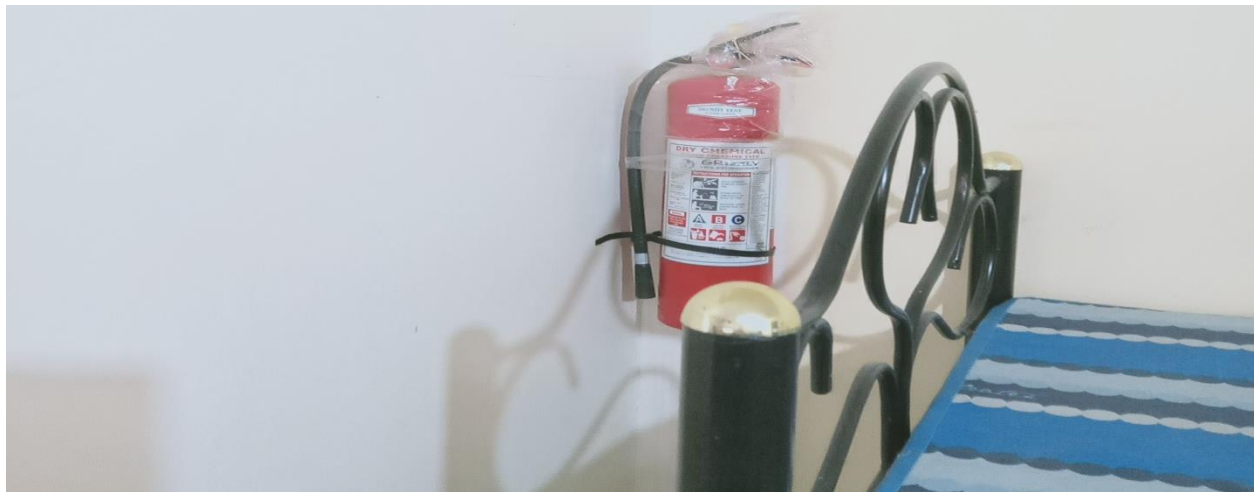
Installed Fire Extinguisher at Male Dormitory

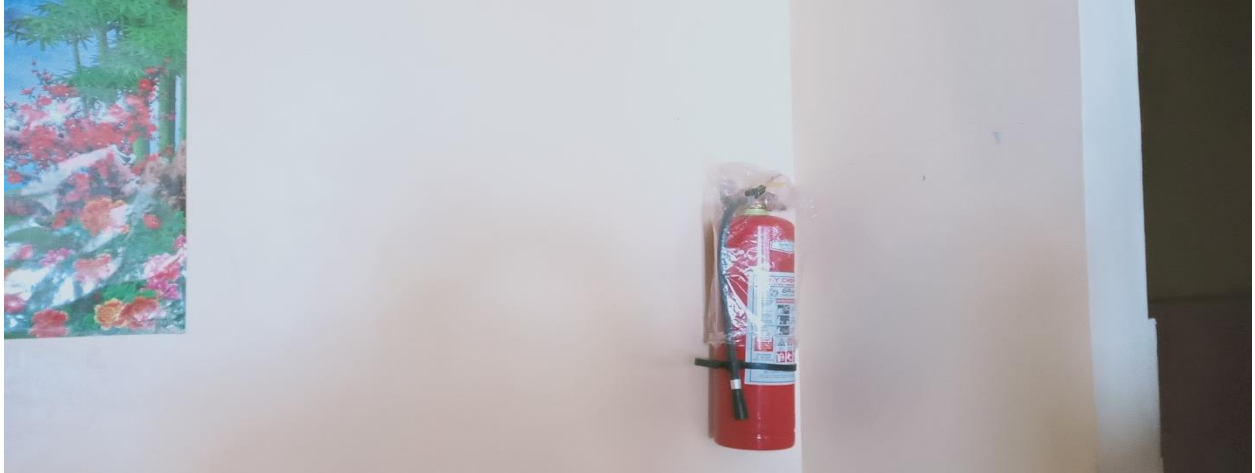
Installed Fire Extinguisher at Female Dormitory

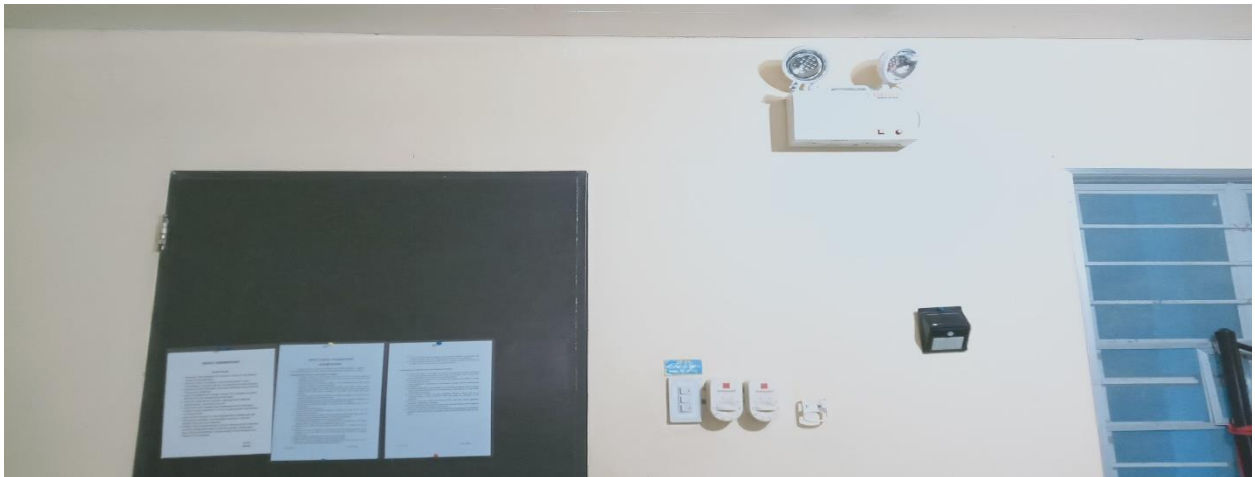
Installed Emergency Lamp at Male Dormitory

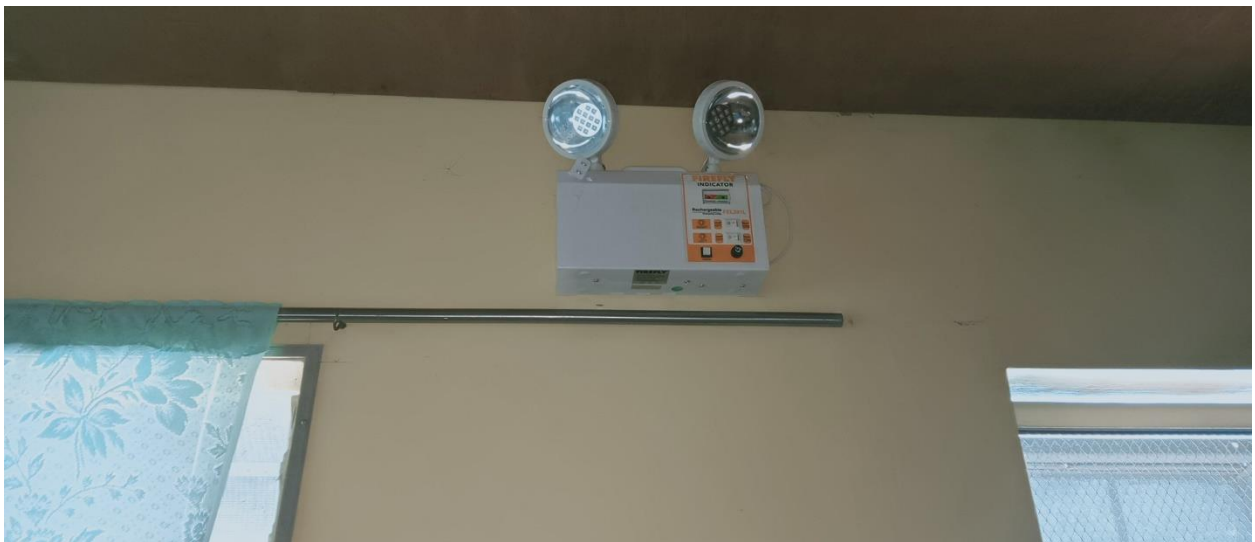
Installed Emergency Lamp at Female Dormitory

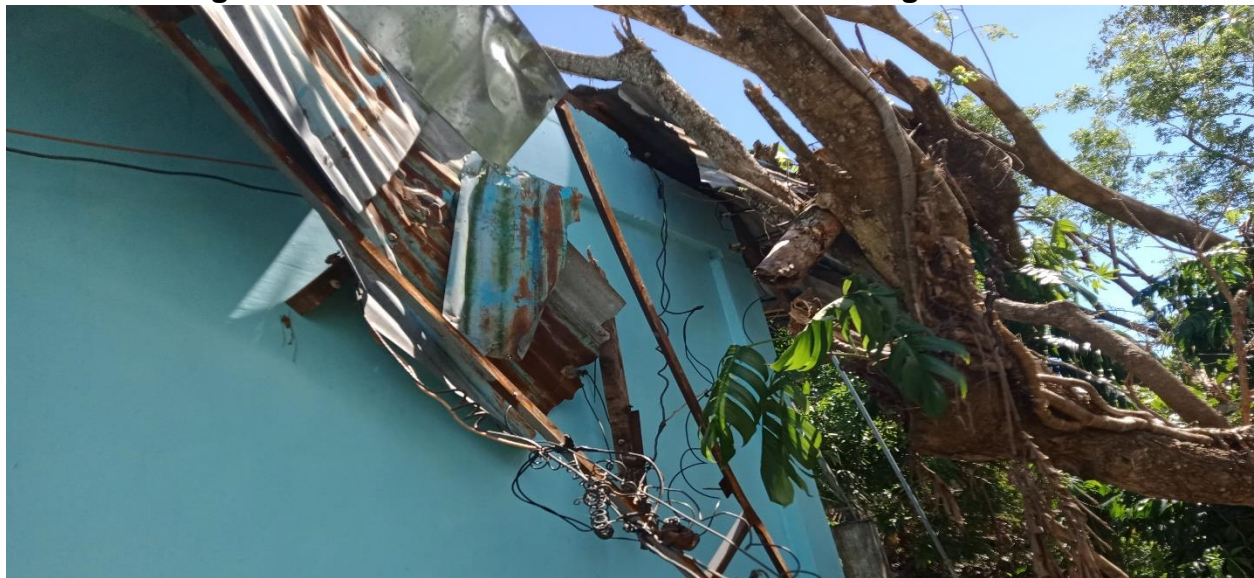
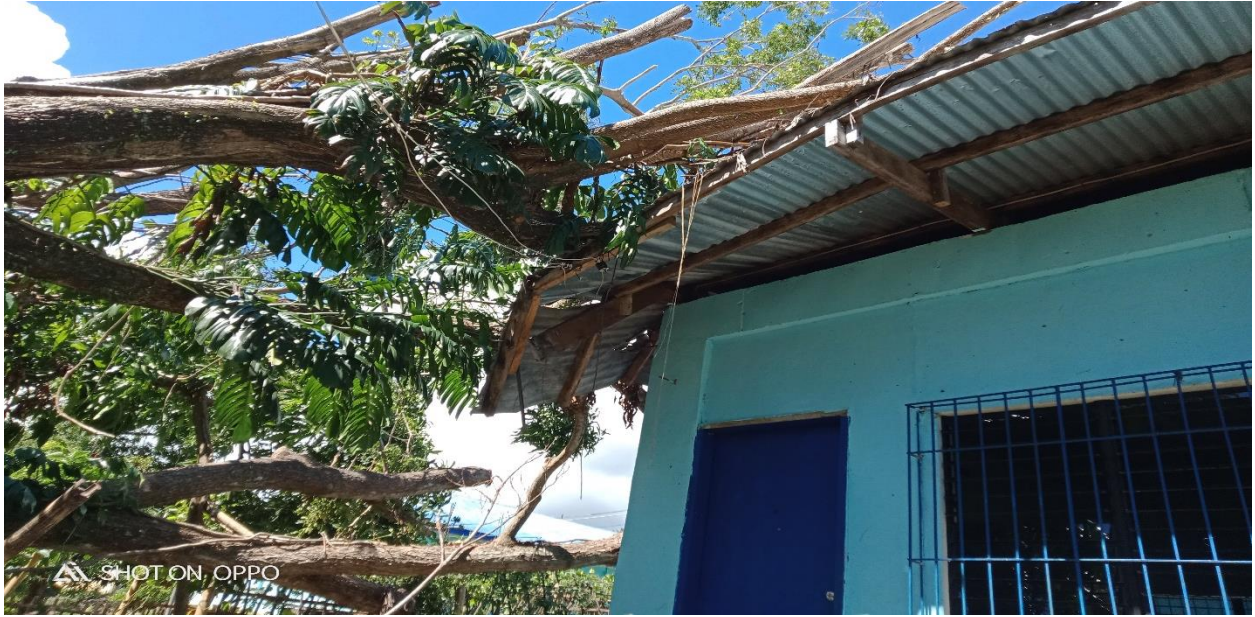
7. Clearing of Fallen trees inclined to the EPAS building

Fallen trees that caused damaged to EPAS Building

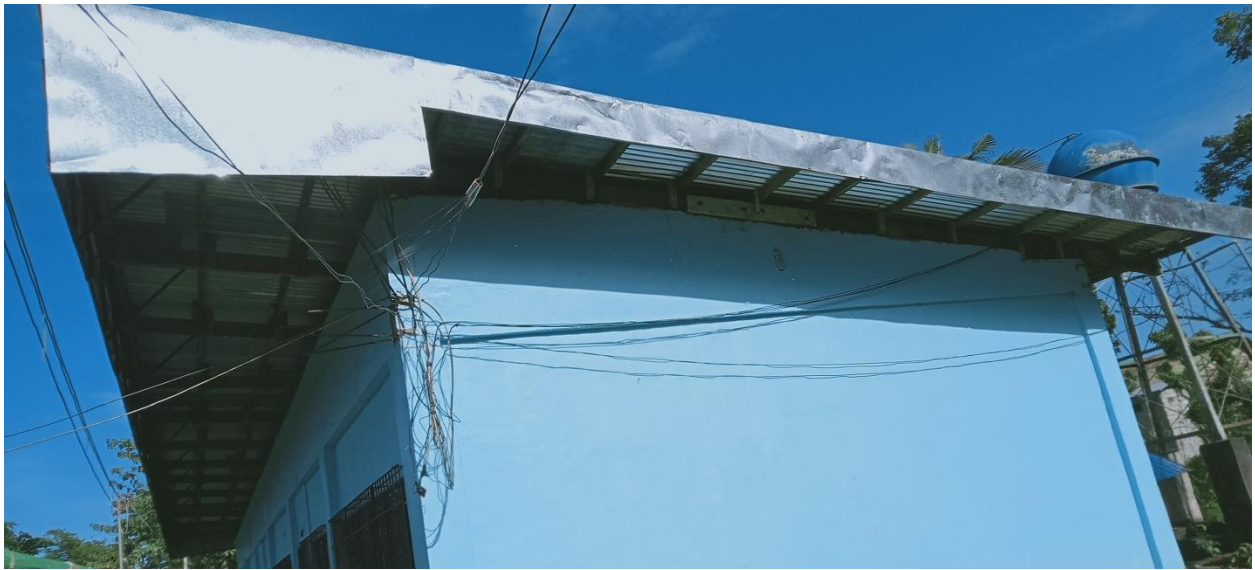
Repaired Building roof of EPAS

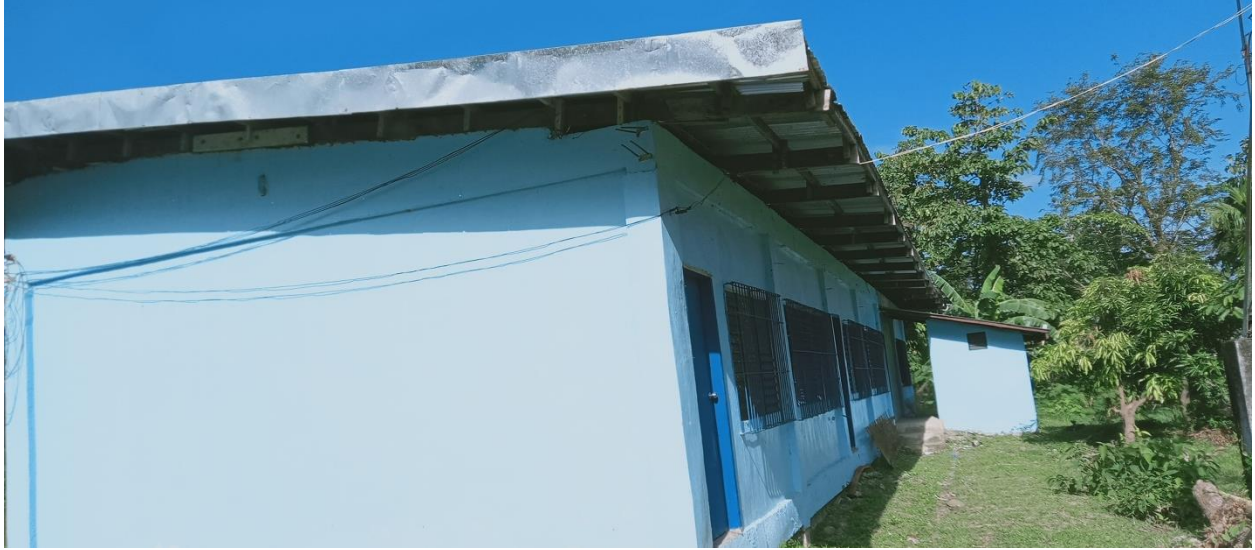
Repaired Building roof of EPAS

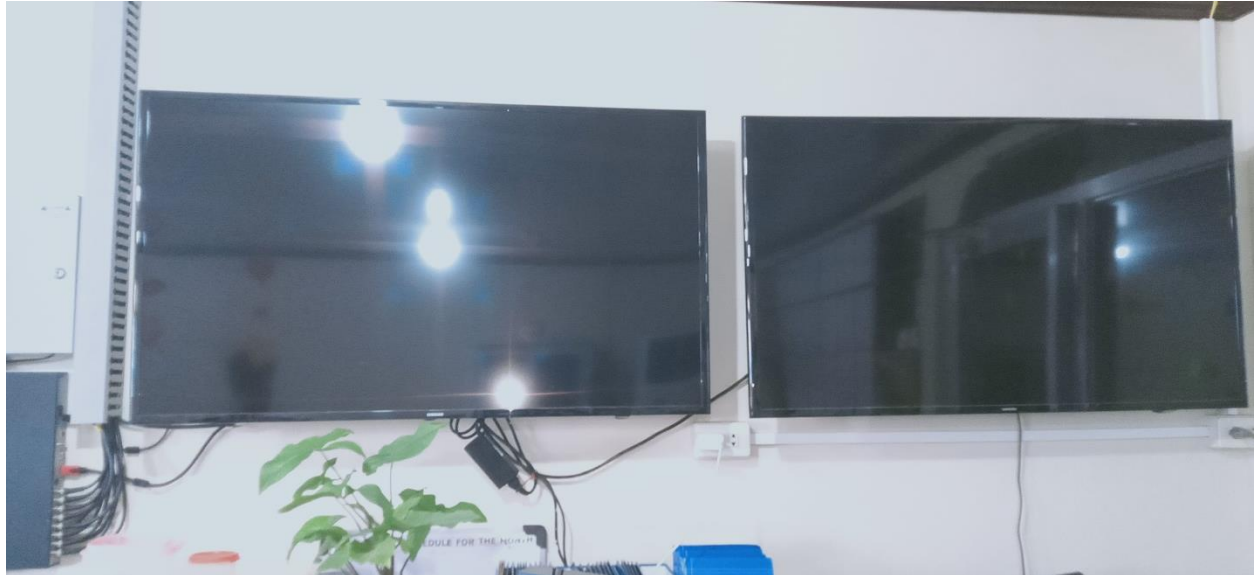
Installed DVR and TV Monitors for CCTV system of the Assessment Center
